A1 Thermal Imaging Services

Thermography Report

Sample Report
Joe Bloggs

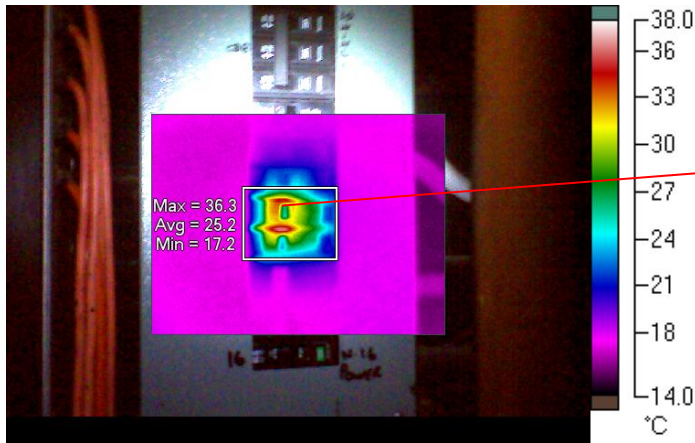
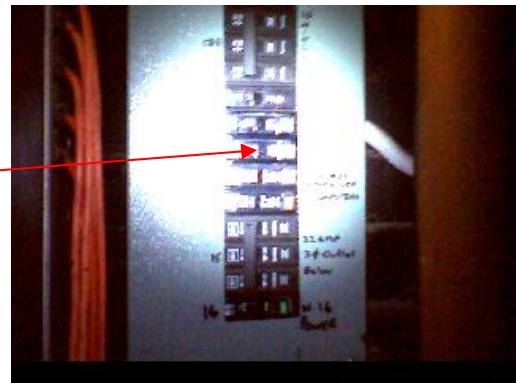
IR000024.IS2

Location	Great Hall
Description	BD1A fuse 13-14 hot
Priority Rating	3
Next inspection	3 Months Yes 6 Months 12 Months

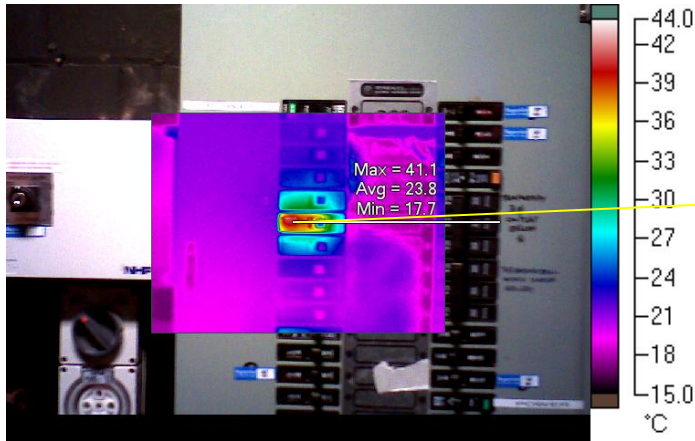
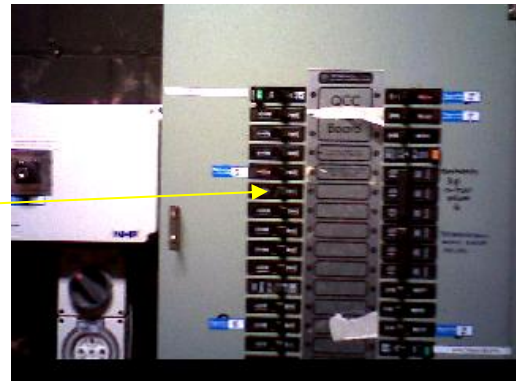
IR000025.IS2
8/28/2008 7:11:52 AM

Location	Bio Room
Description	DB A10 fuse 11 very hot
Priority Rating	2
Next inspection	3 Months- Yes 6 Months 12 Months

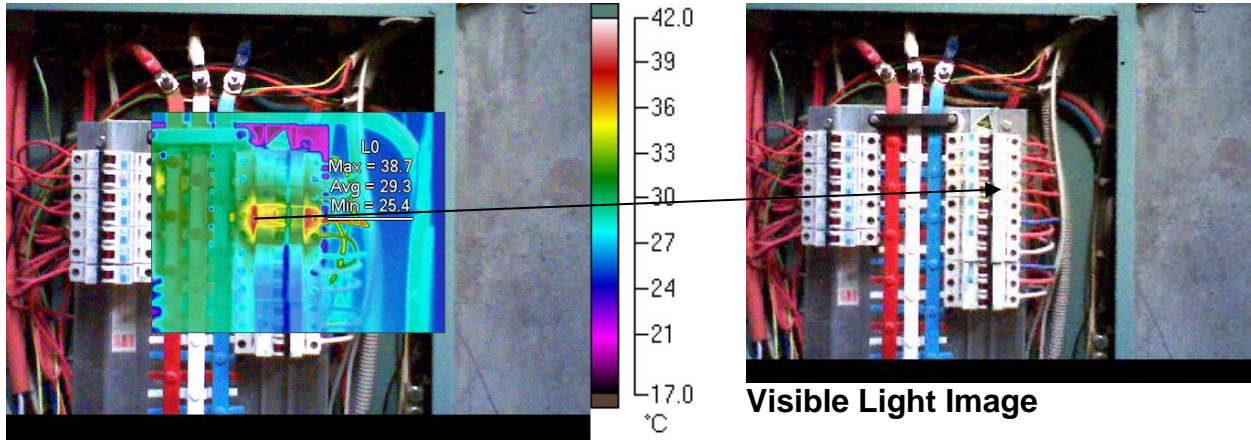
IR000222.IS2

Location	CP 2 H1
Description	Fuse 8 pool plant
Priority Rating	Low Medium - yes High
Next inspection	Within 12 Months
