A1 Thermal Imaging Services

Thermography Report

Sample Report
Joe Bloggs

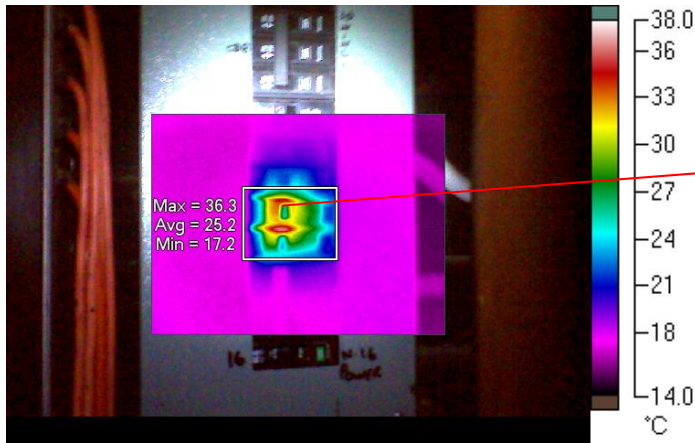
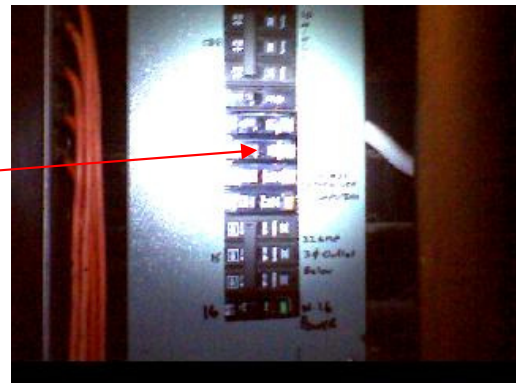
IR000024.IS2
8/28/2008 7:04:14 AM

Location	Great Hall
Description	BD1A fuse 13-14 hot
Priority Rating	3
Next inspection	3 Months Yes 6 Months 12 Months

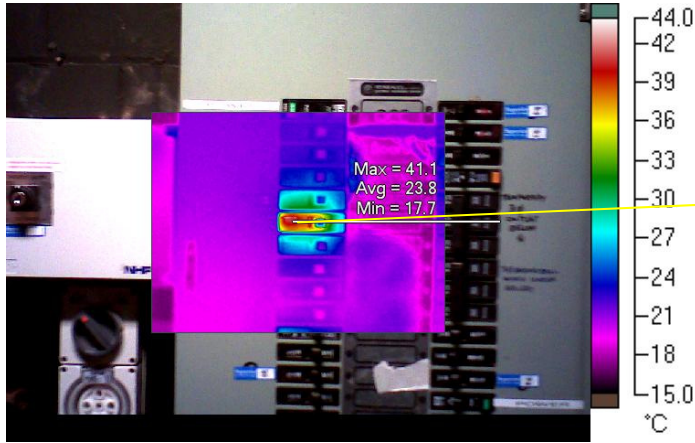
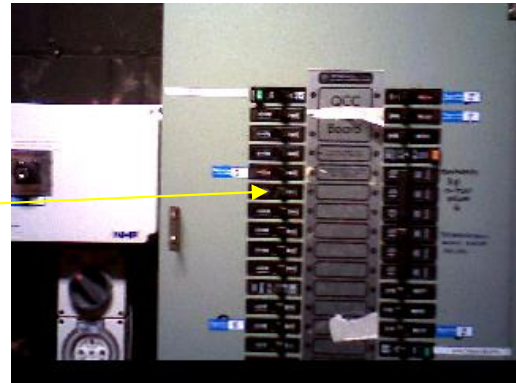
IR000025.IS2

Location	Bio Room
Description	DB A10 fuse 11 very hot
Priority Rating	2
Next inspection	3 Months- Yes 6 Months 12 Months

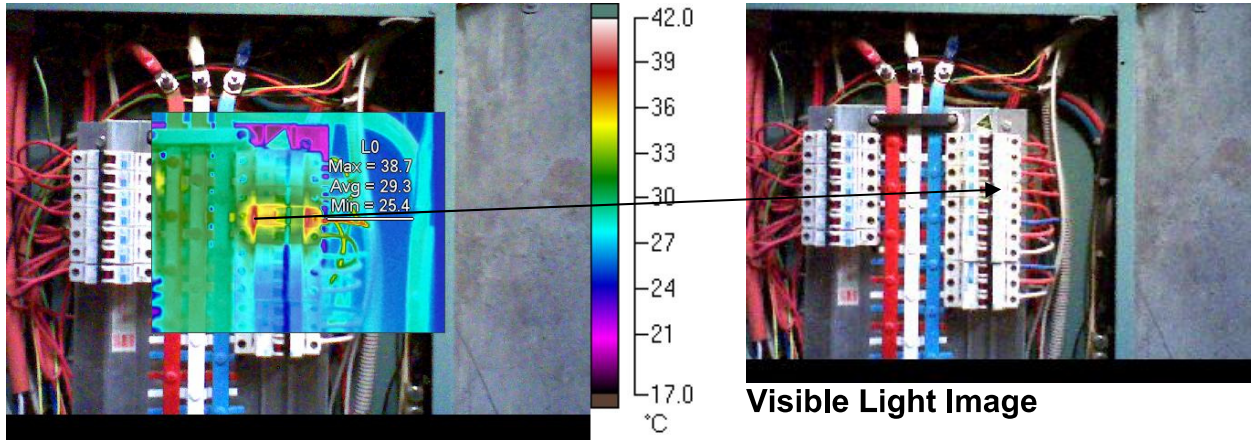
IR000222.IS2
5/28/2009 11:06:45 AM

Location	CP 2 H1
Description	Fuse 8 pool plant
Priority Rating	Low Medium - yes High
Next inspection	Within 12 Months
